IN THE UNITED STATES DISTRICT COURT
FOR THE SOUTHERN DISTRICT OF TEXAS
HOUSTON DIVISION

COLE & ASHCROFT, LP DBA

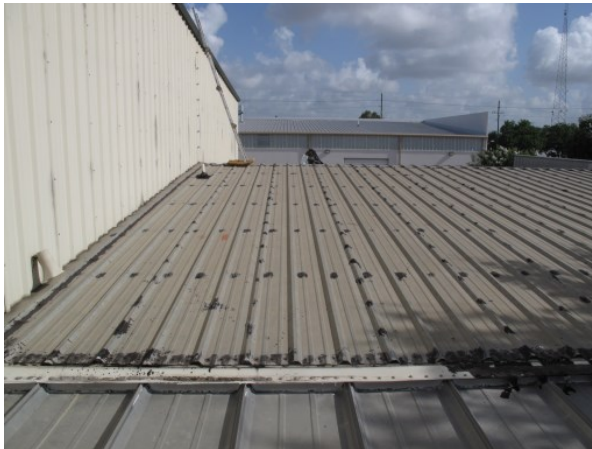
Figure 3: General view of lower roof. Remedial sealant applied at exposed fasteners at R-panels.

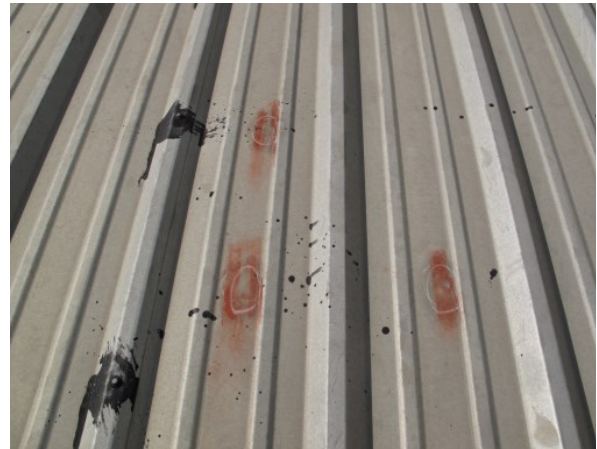
Figure 4: General area of roof above moisture distress/deterioration at roof decking and South Storage Room.

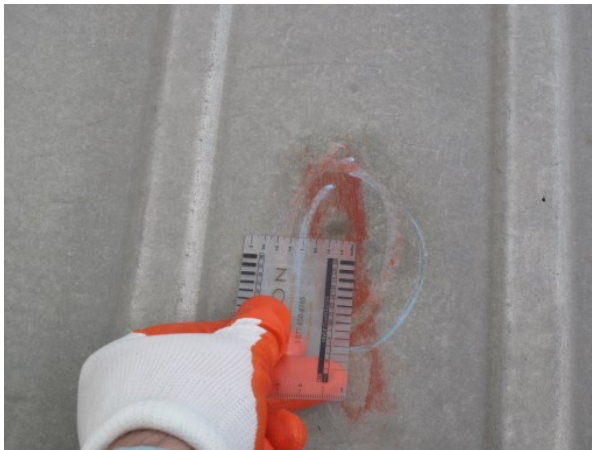
Figure 5: Burnish mark at circular indentation that measured approximately 1/2" in diameter.

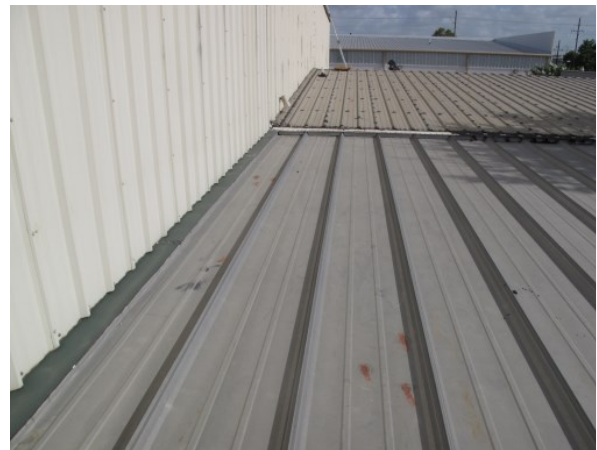
Figure 6: Circular indentations at pans at standing seam metal roof panels.

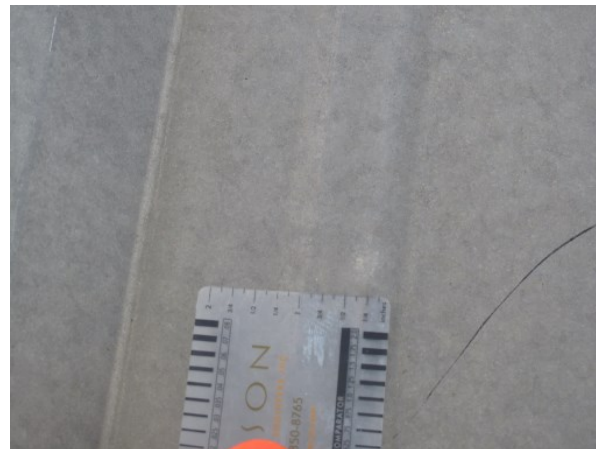
Figure 12: Approximately 3/8" burnish mark with no indentation.

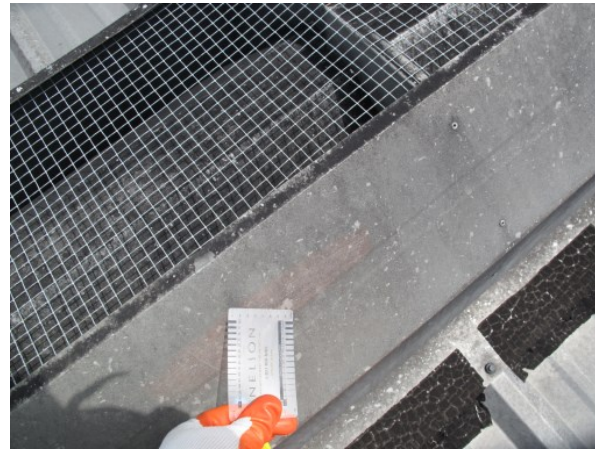
Figure 16: Burnish marks at metal ridge vent, with no coincident indentation.

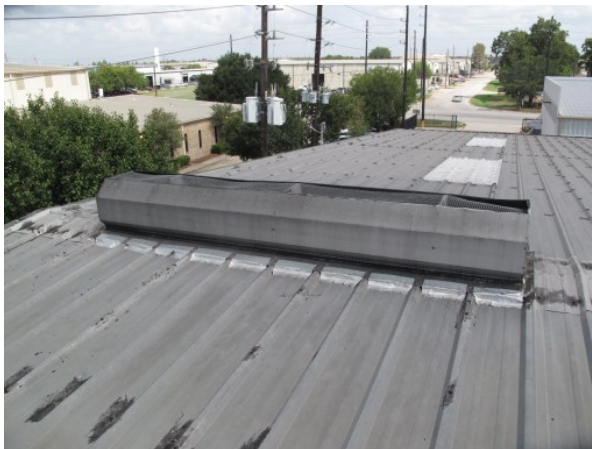
Figure 17: Newer-looking membrane tape flashing over closures at flashing.

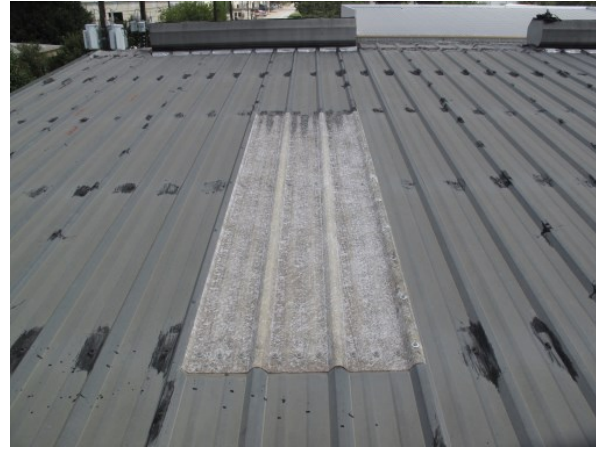
Figure 20: No indentations or fractures at the roof lites.

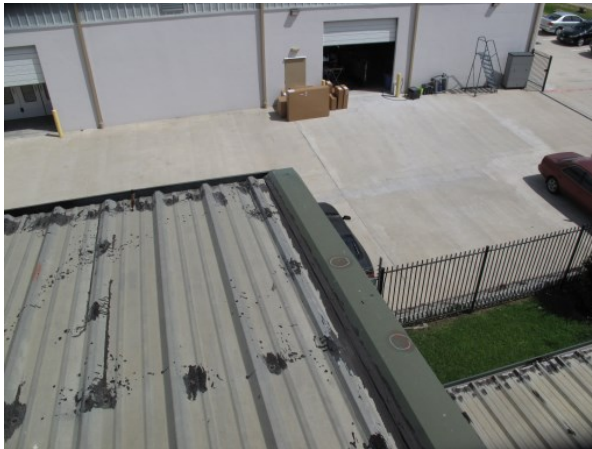
Figure 21: Circular indentations at the rake trim at upper roof.

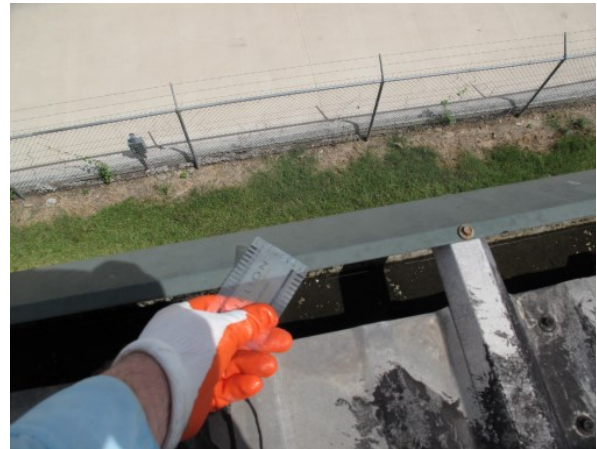
Figure 22: Burnish marks at metal gutter. No indentations at gutter.

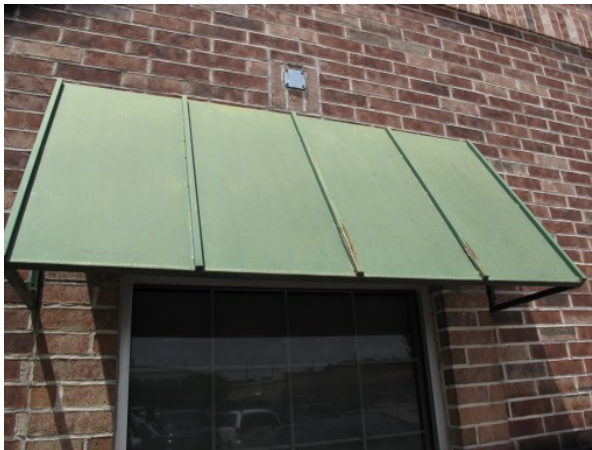
Figure 23: Burnish marks at metal awnings at the east and north elevations. No indentations.

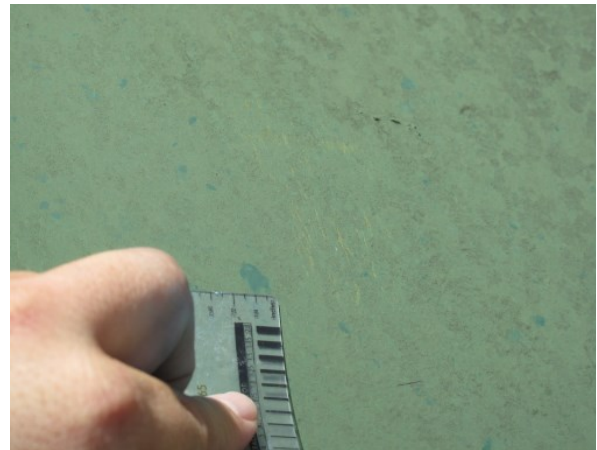
Figure 24: Close-up of burnish mark that measured approximately 3/8" wide.

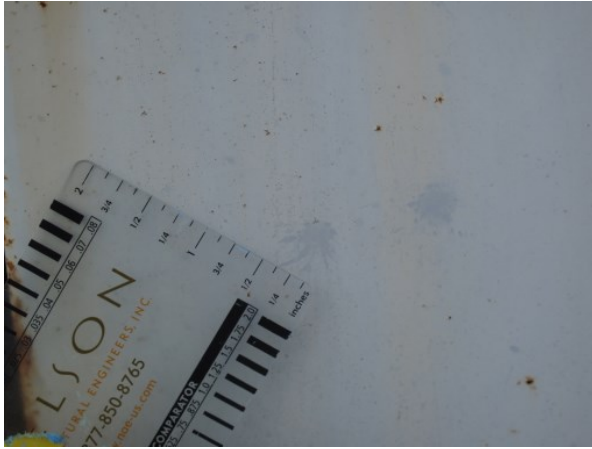
Figure 31: Burnish mark measured approximately 3/8" wide.

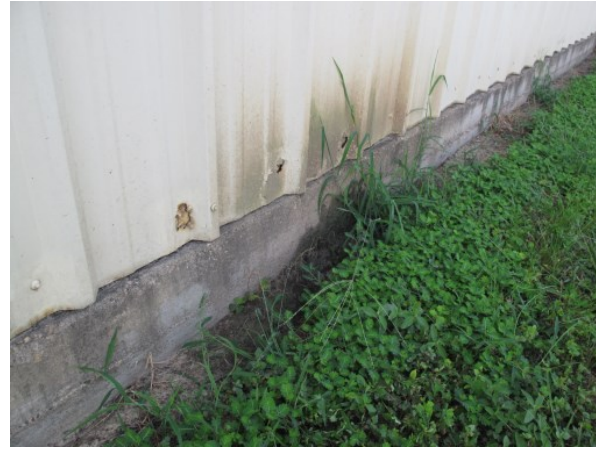
Figure 32: Corrosion and missing material at fasteners at the base of the walls.

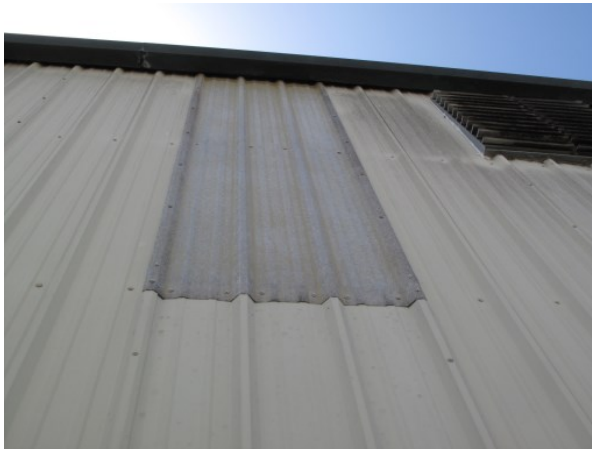
Figure 33: No fractures at fiberglass wall lites.

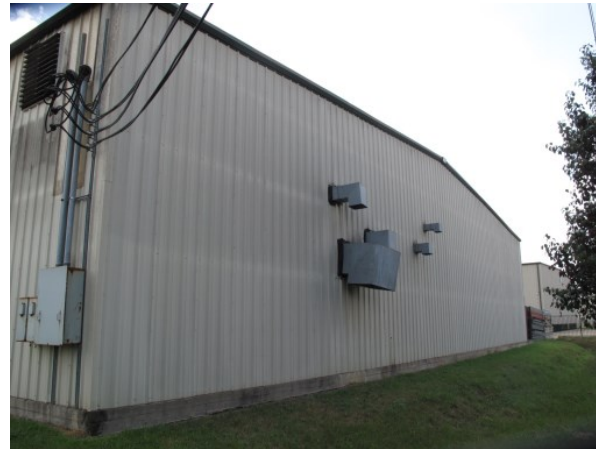
Figure 34: West elevation.

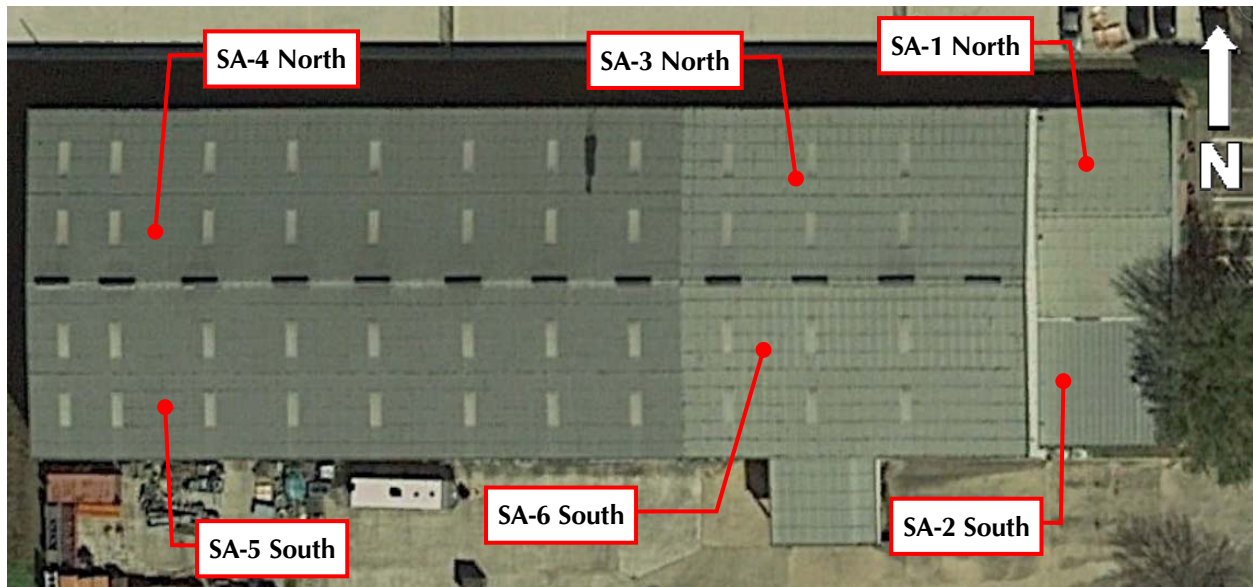
Figure 37: Aerial view of subject roof with sample area locations and true north, annotated by Nelson (Google, Inc. 2019)

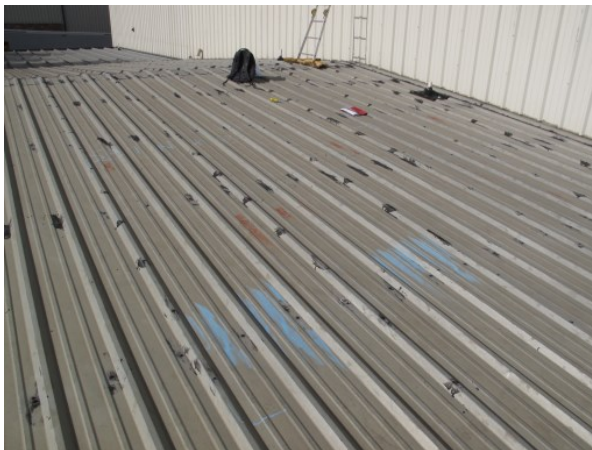
Figure 38: Sample Area 1.

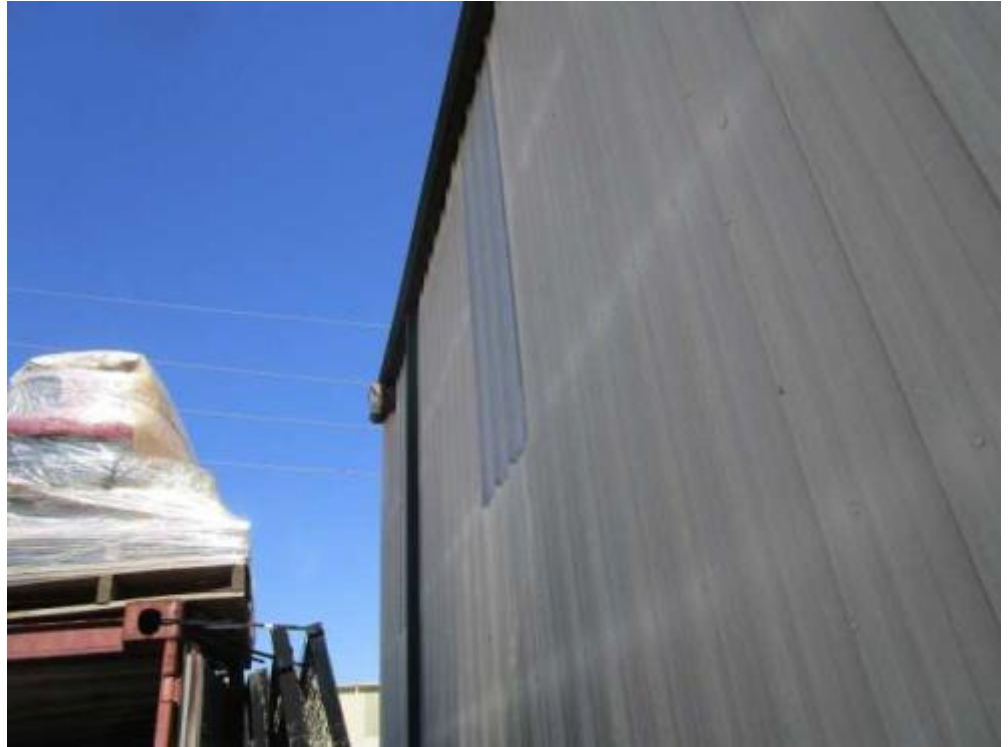
- 30 123-Interior
Date Taken: 6/11/2020
Taken By: Randy LeBlanc

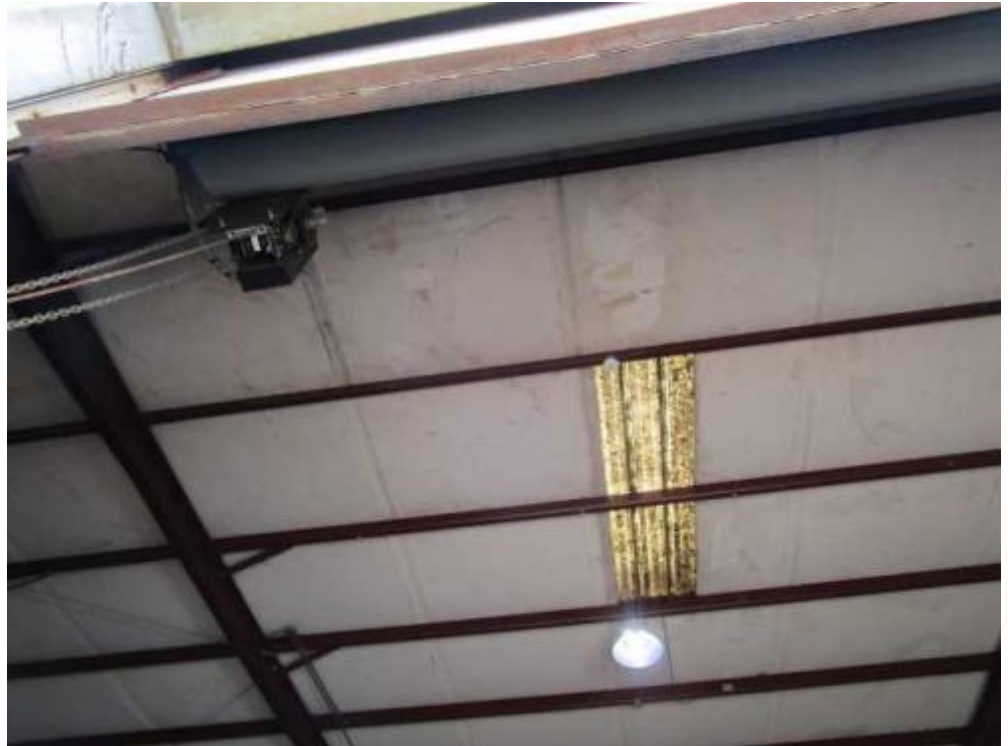
Noted water intrusion through insulation.

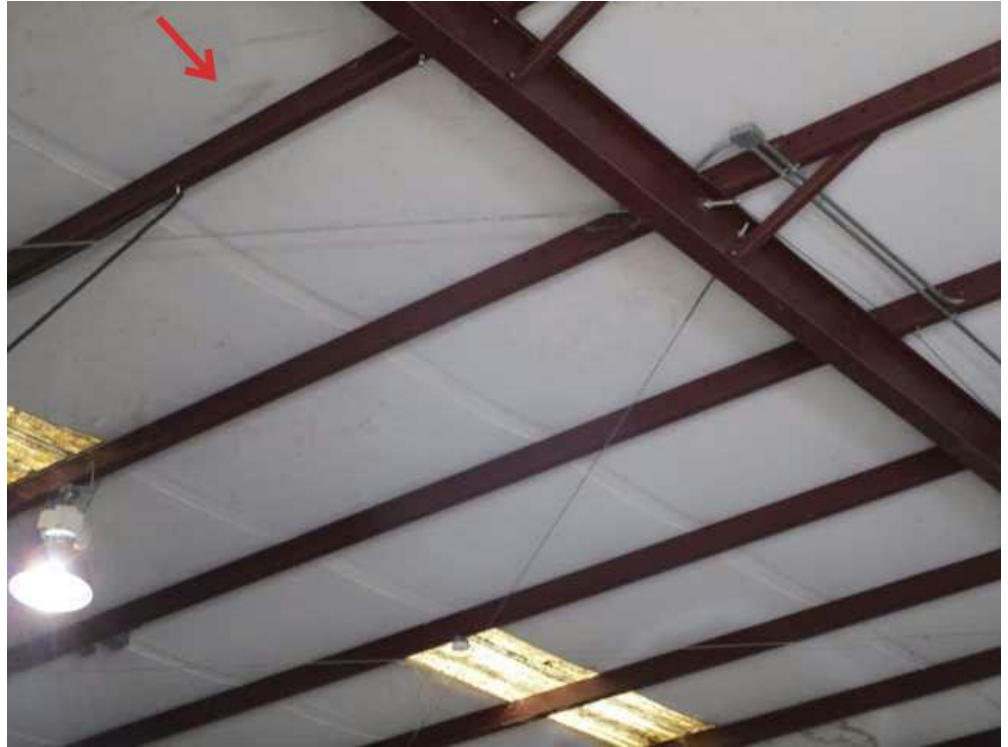
- 32 125-Interior
Date Taken: 6/11/2020
Taken By: Randy LeBlanc

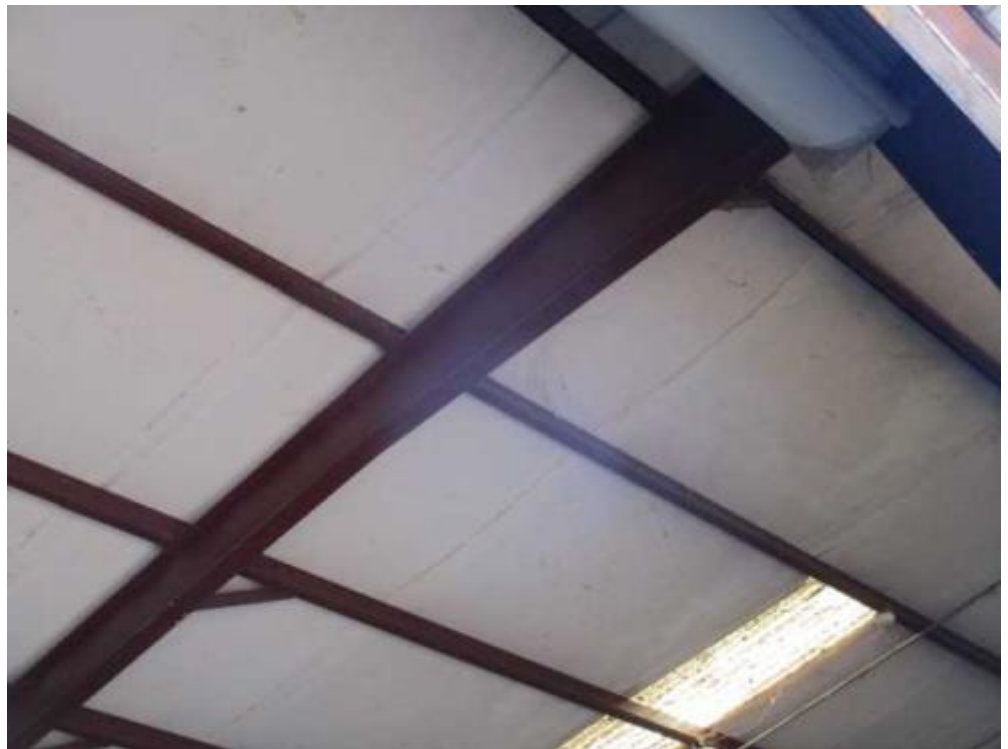
Noted water intrusion through insulation.

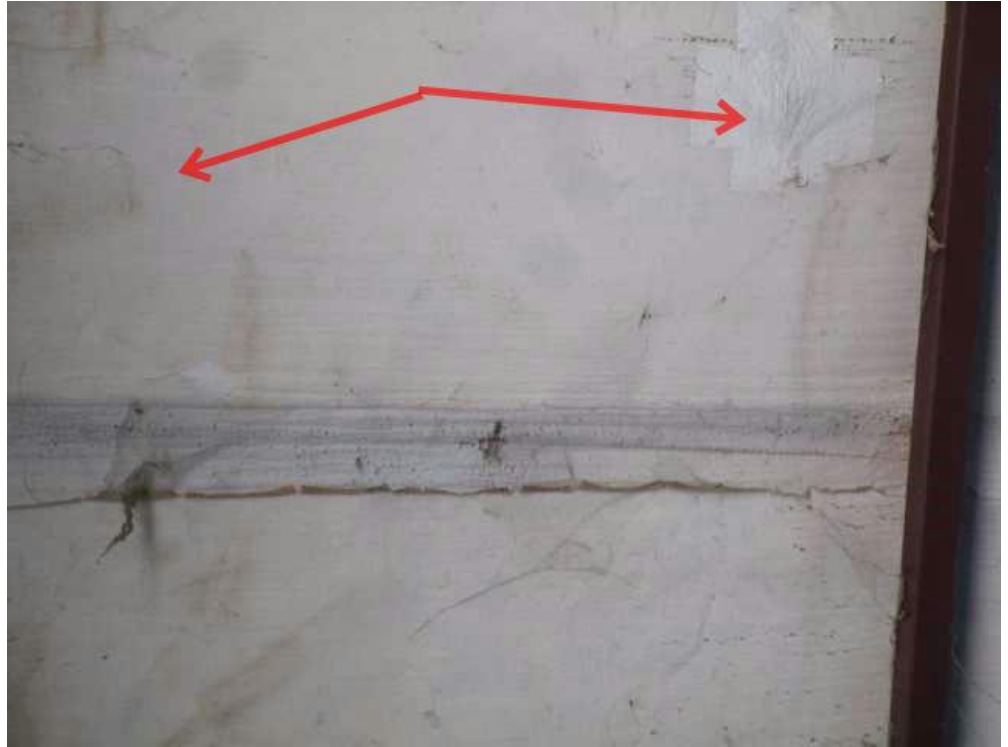
Noted water intrusion through insulation.

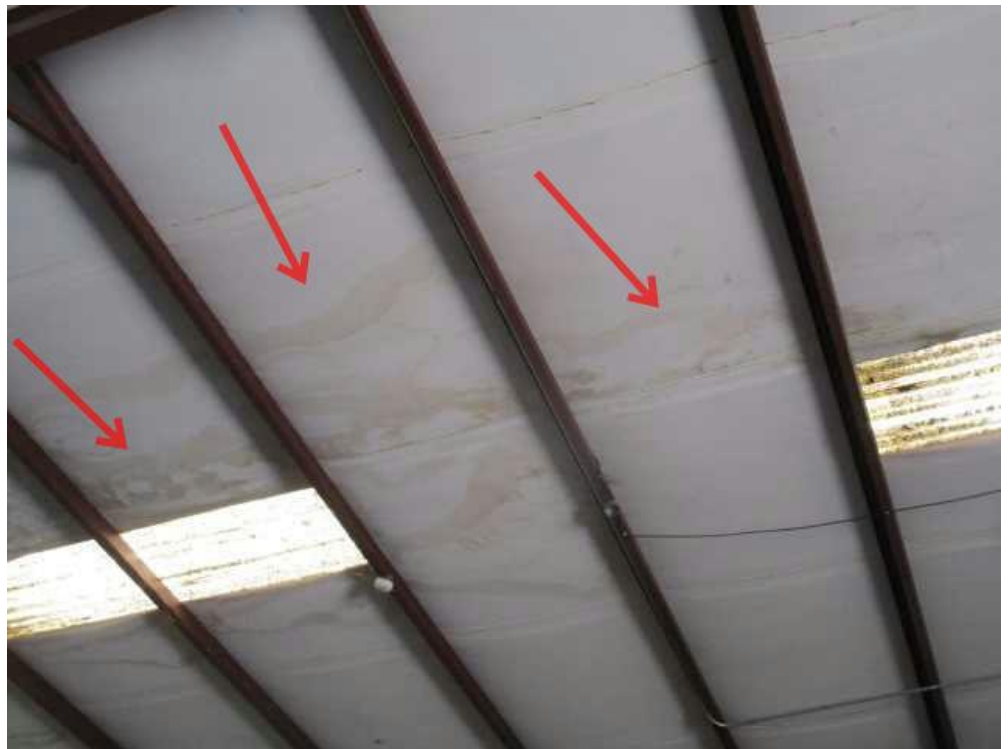
Noted water intrusion through insulation.

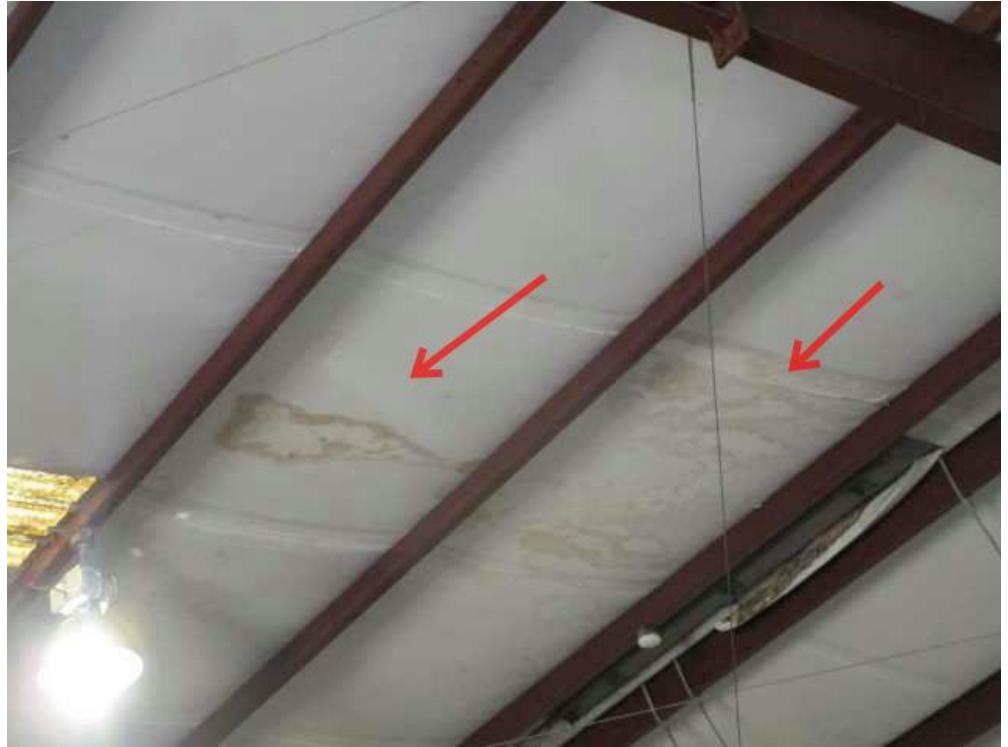
- 36 129-Roof
Date Taken: 6/11/2020
Taken By: Randy LeBlanc
Roof Agreed to by Both Appraisers to R&R
